*Pre-Remedial Design Study  
Port of Tacoma Industrial Yard  
Hylebos Waterway  
Commencement Bay  
Tacoma, Washington*

*Prepared by  
Hart Crowser*

*October 30, 1998  
J-4858-03*

**AFFIDAVIT OF ALAN F. WESTON REGARDING PCB DISTRIBUTIONS ON  
THE EMBANKMENTS AND IN THE SEDIMENTS AT THE MOUTH OF THE  
HYLEBOS WATERWAY**

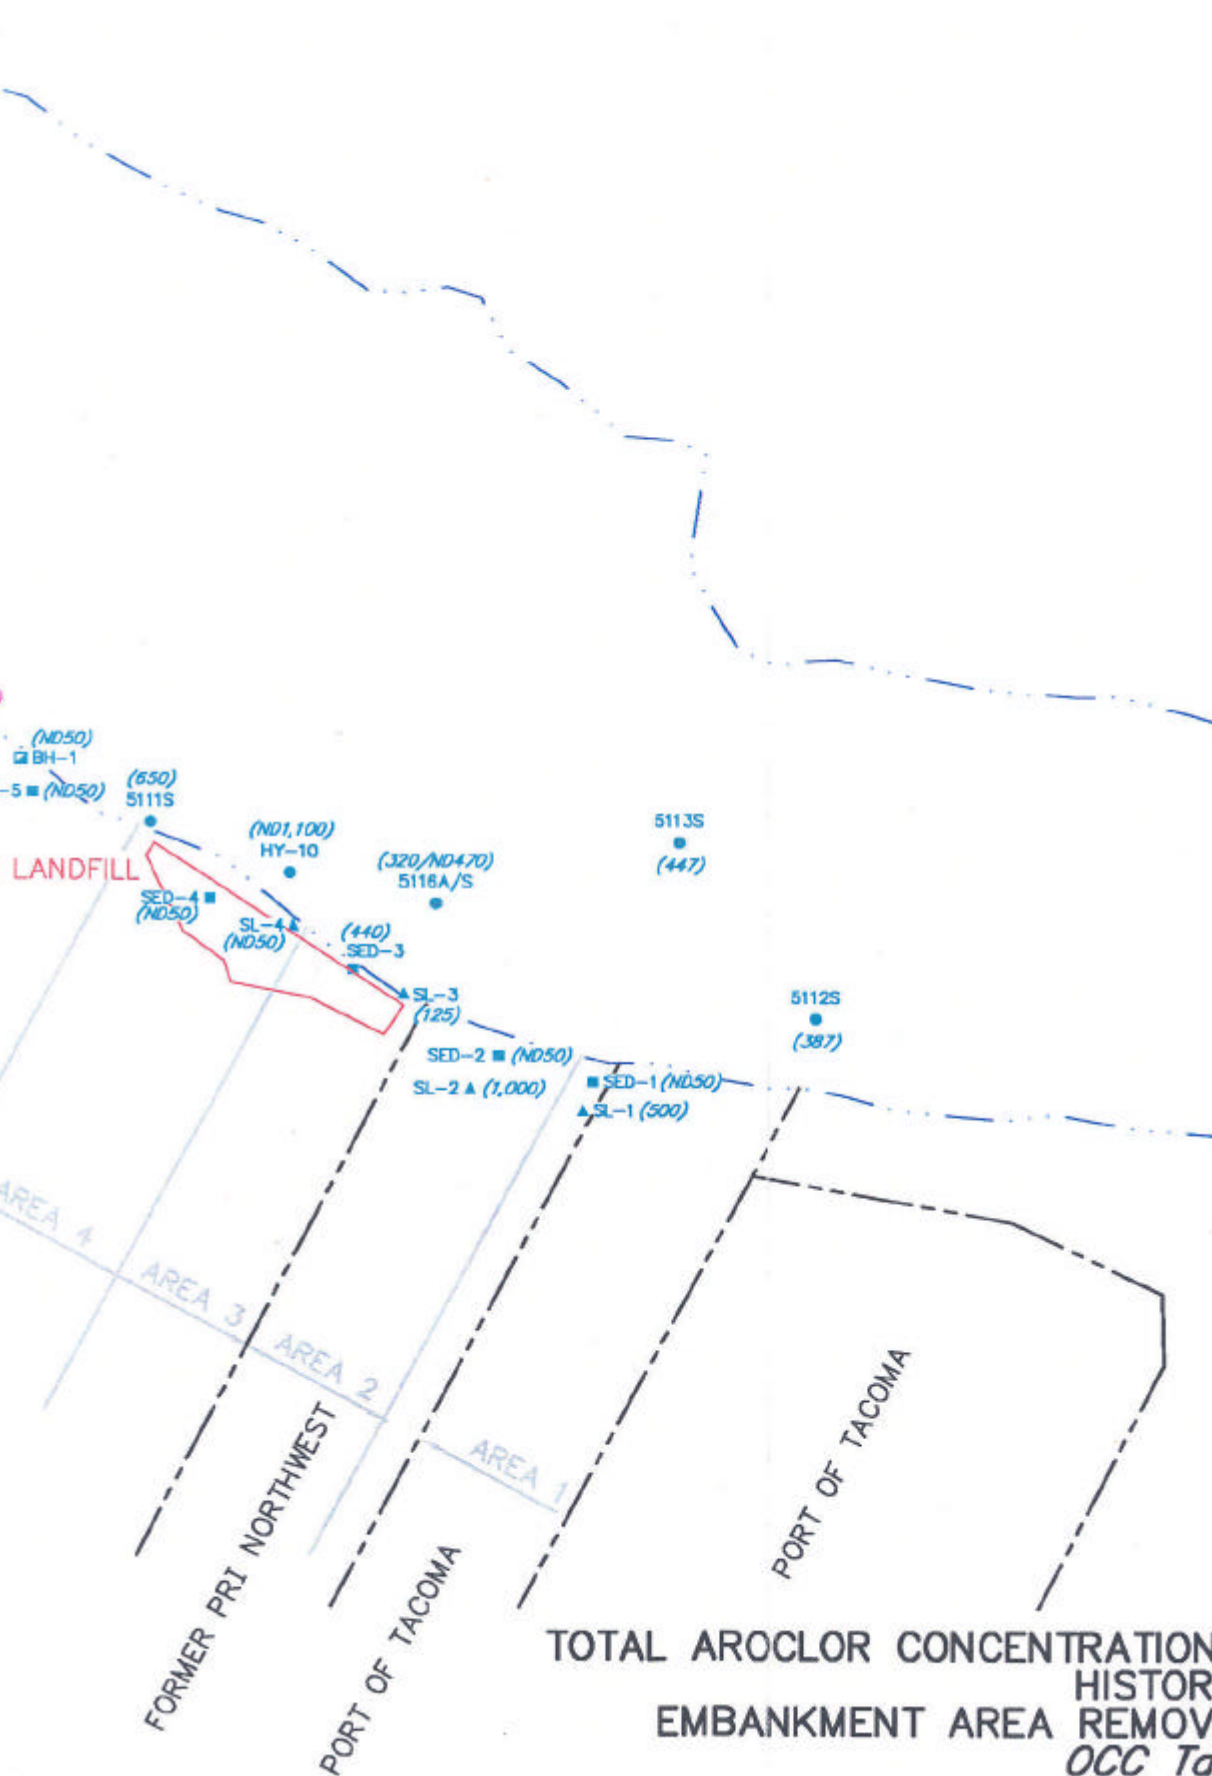
figure 1

TOTAL AROCLOR CONCENTRATIONS (ug/Kg)  
 HISTORICAL DATA  
 EMBANKMENT AREA REMOVAL ACTION  
 OCC Tacoma, Inc.

11. The GC/ECD data showed three different patterns of PCB congeners in these locations, as illustrated by Graphs 1 through 7. The data are summarized in Figure 1, indicating sample locations, PCB concentrations, and different colors for the three patterns.

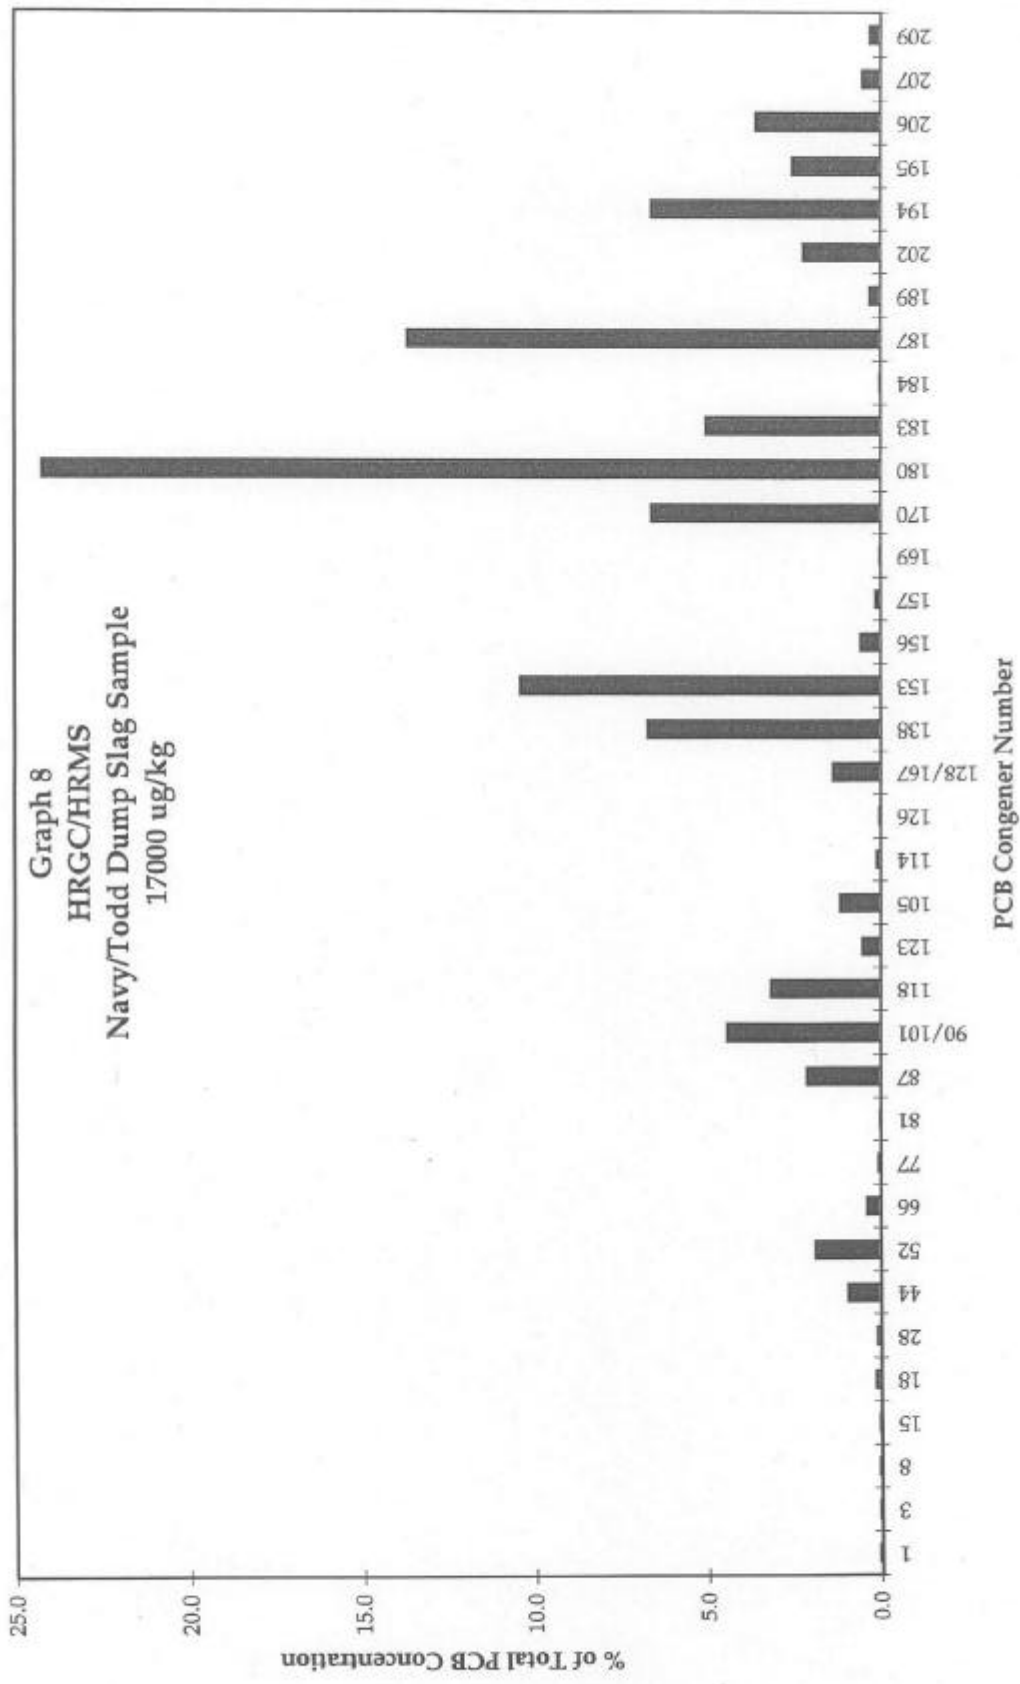
18. Again, the highest PCB concentrations were detected in the slag and soil samples collected from the Navy/Todd Dump (22,000 and 17,000 ppb, respectively). These samples had a very strong PCB congener pattern (see Graph 8) that matched Aroclor 1260 (see Graph 9).

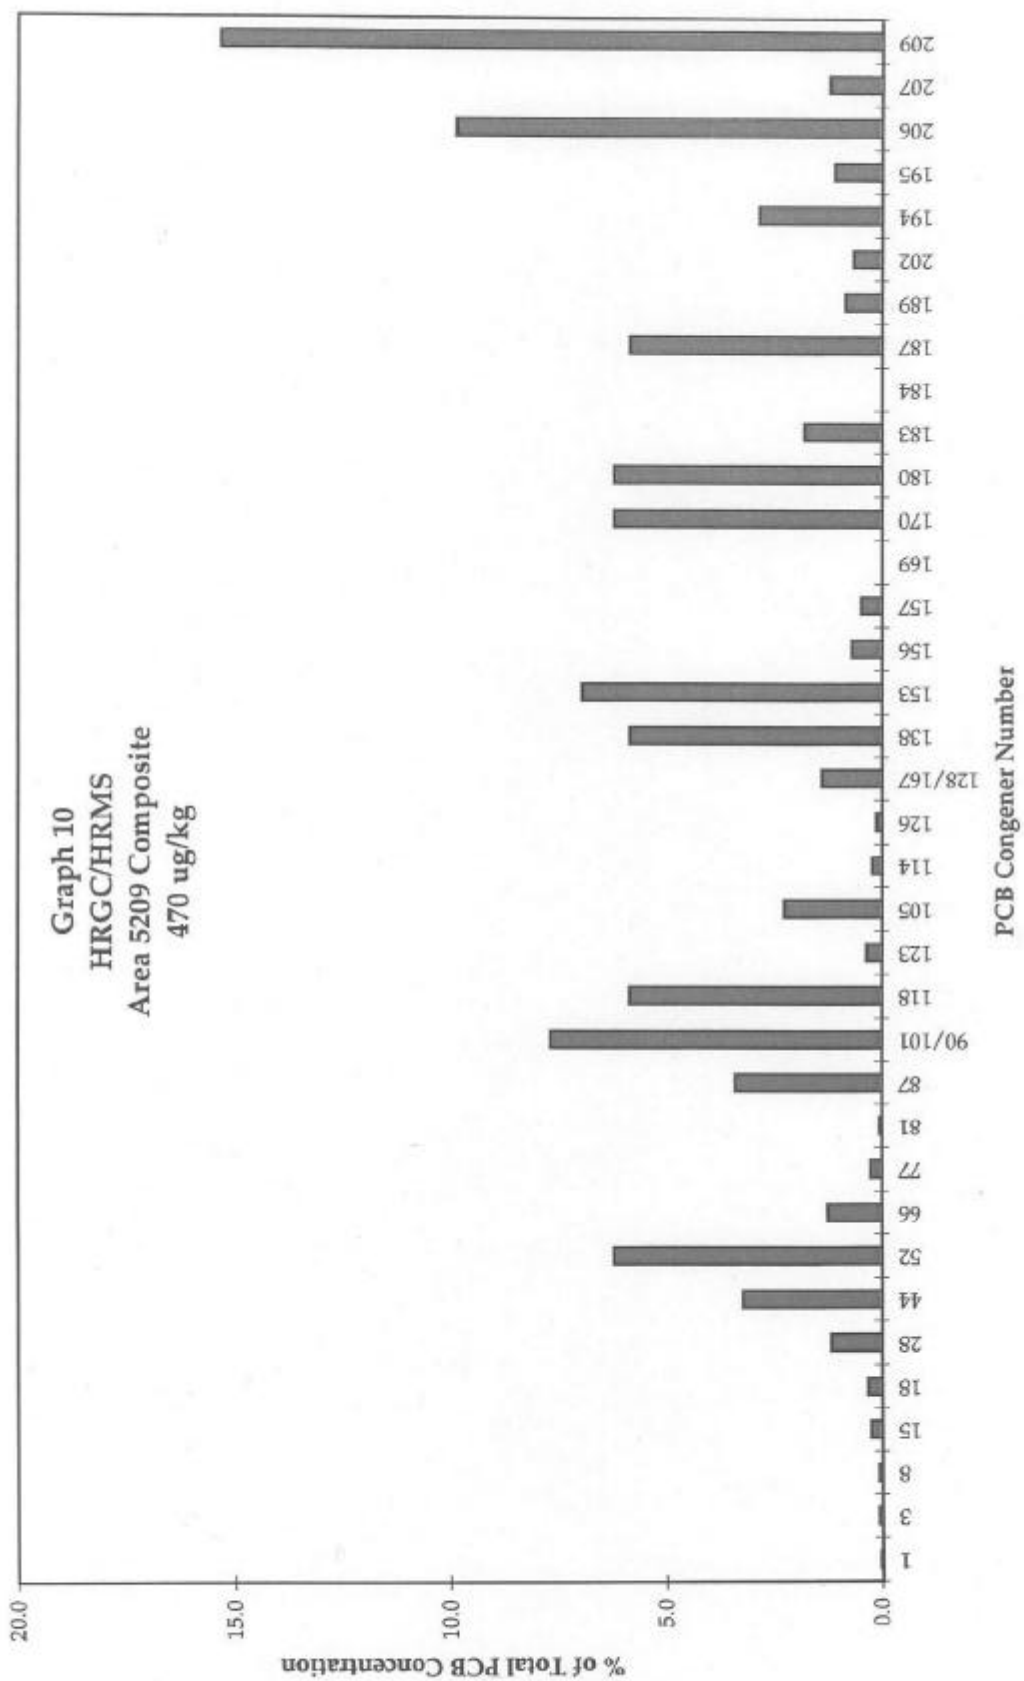
19. The majority of the other embankment samples taken from Parcels 1 and 2, including the Parcel 1 composite, showed the same Aroclor 1260 pattern observed at the Navy/Todd Dump. An example is depicted in Graph 10.
